# National Transportation Safety Board

## Aircraft Accident Investigative Update

WASHINGTON (Nov. 15, 2019) – The National Transportation Safety Board (NTSB) has issued an investigative update for the October 17 runway overrun at Tom Madsen Airport, Unalaska Alaska (Port of Dutch Harbor).

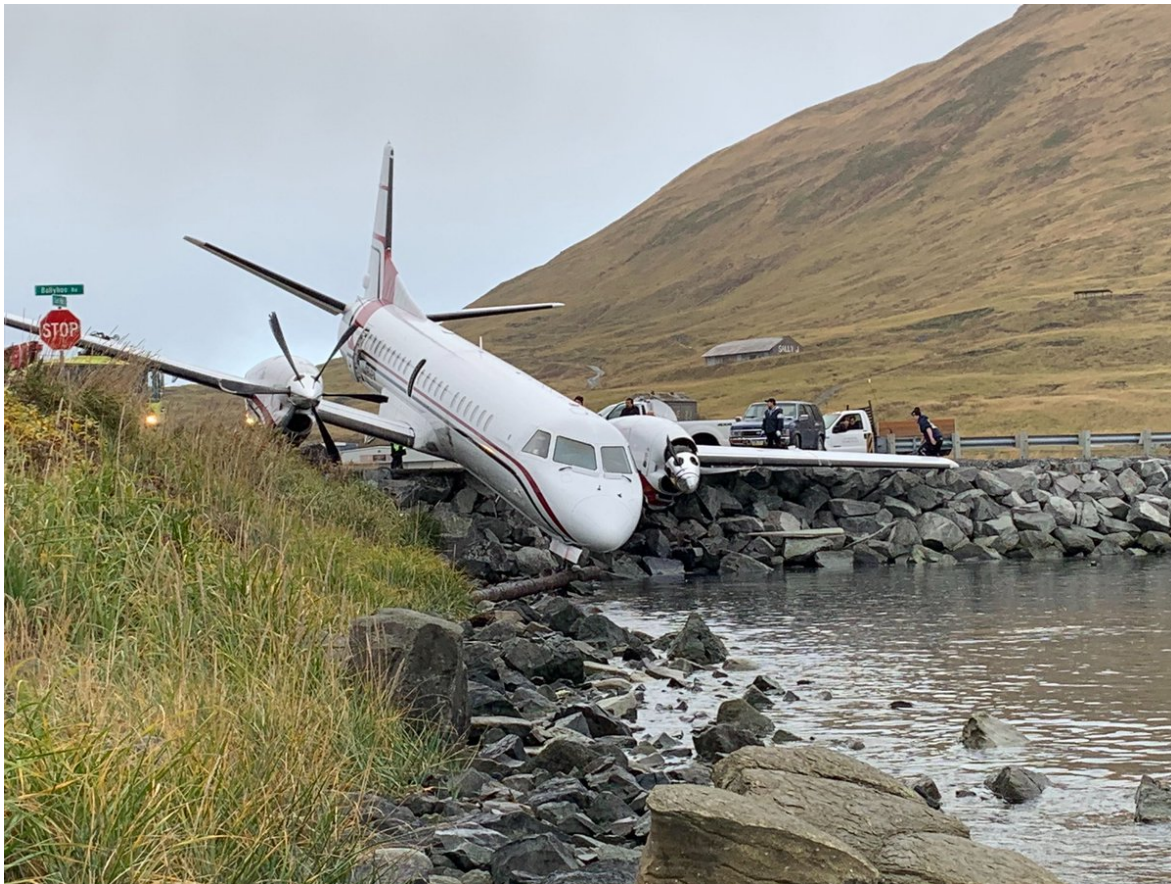
*Figure 1 View of the airplane looking northwest*

Witness marks indicated that the airplane departed the runway and overrun area, traversed a section of grass, impacted a 3- to 4-ft high chain-linked perimeter fence with evidence of left engine propeller contact, crossed a ditch, impacted a large rock, and crossed a public roadway. The left

wing or left engine propeller struck a 4 to 5 ft vertical signal post on the opposite shoulder of the road and the left propeller struck a 6 to 8-ft high yellow diamond shaped road sign. There were strike marks consistent with the right engine's propeller tips contacting the ground near where the airplane came to rest.

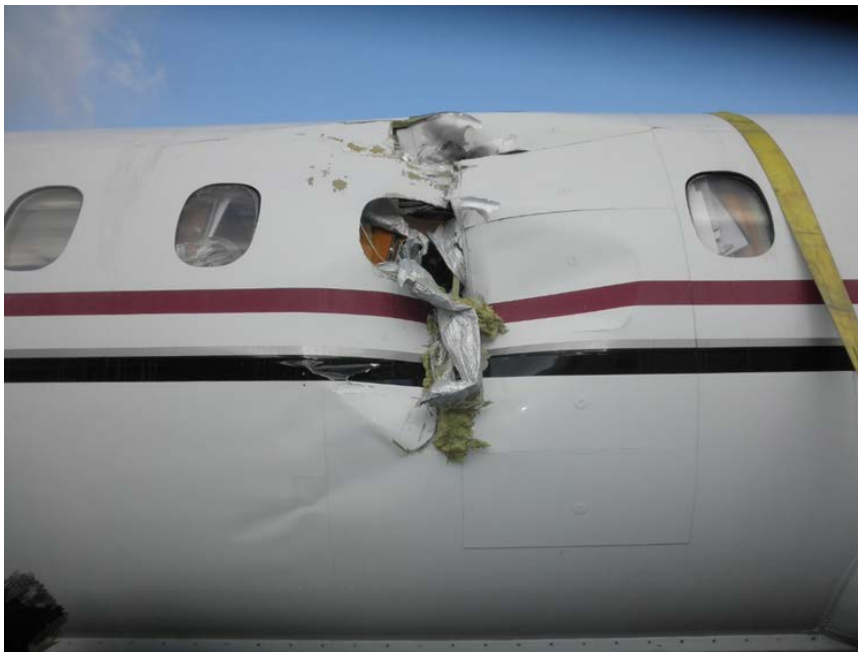
Examination of the fuselage revealed a hole and impact damage to the left forward fuselage around the 5th window (Figure 2). A propeller blade was loosely stuck in the surrounding structure external to the fuselage and another propeller blade was found inside the fuselage. All cabin seats (15 rows) were intact and secure to the floor except for seat 4A, which was displaced and damaged. The damaged area of the cabin was contained within the area on the left side between fuselage station (FS) 399 (seat 3A) and FS 488 (seat 6A), with extensive damage evident at FS 435. The left side overhead compartment (FS 399 to FS 488) partially separated from its mounts and descended about 6 to 12 inches with various brackets and debris hanging down into the seats or laying on the floor. The wall panel separated at FS 399 and displaced rearward and inward. The 4A window fuselage frame was located on the cabin floor.

*Figure 2 Damage to left side of fuselage*

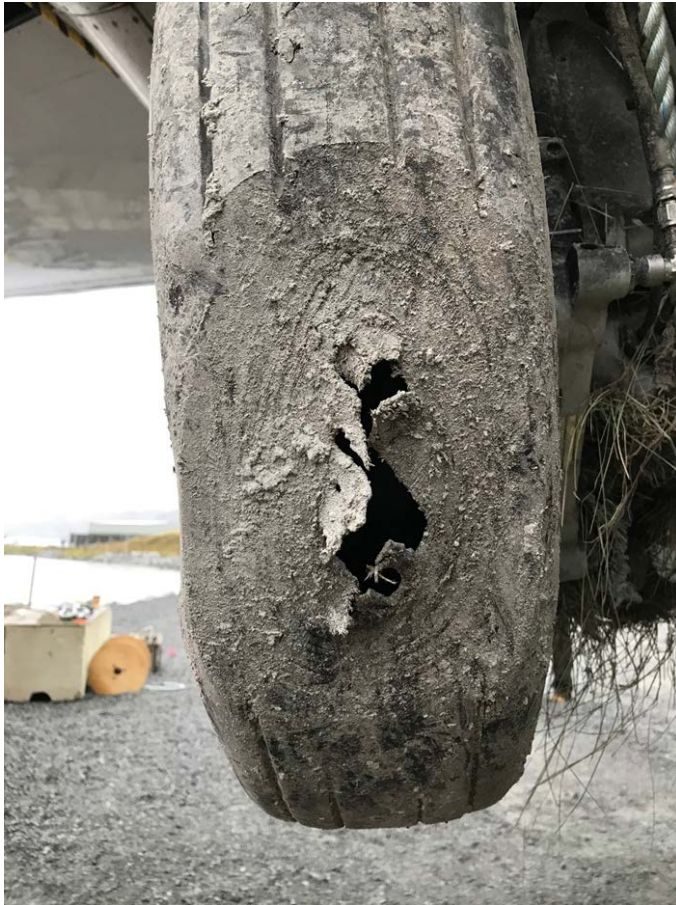
The four main landing gear tires and brake assemblies were examined. The tire pressures were documented prior to moving the airplane. The left outboard (OB) tire was deflated, the left inboard (IB) tire was at 135 psi, and the right OB and IB tires were greater than 160 psi (maximum reading of the available gauge). A placard on the landing gear door indicated that the allowable pressures were between 165-173 psi. The left OB tire had an area approximately 11 inches in length which was ground flat all the way through the tire (See Figure 3). Because hydraulic pressure could not be applied, only an approximate measurement of the carbon brake wear pins could be made. All

wear pins were in serviceable ranges. Multiple components were removed for further examination and testing.

*Figure 3 Damage to left outboard tire*

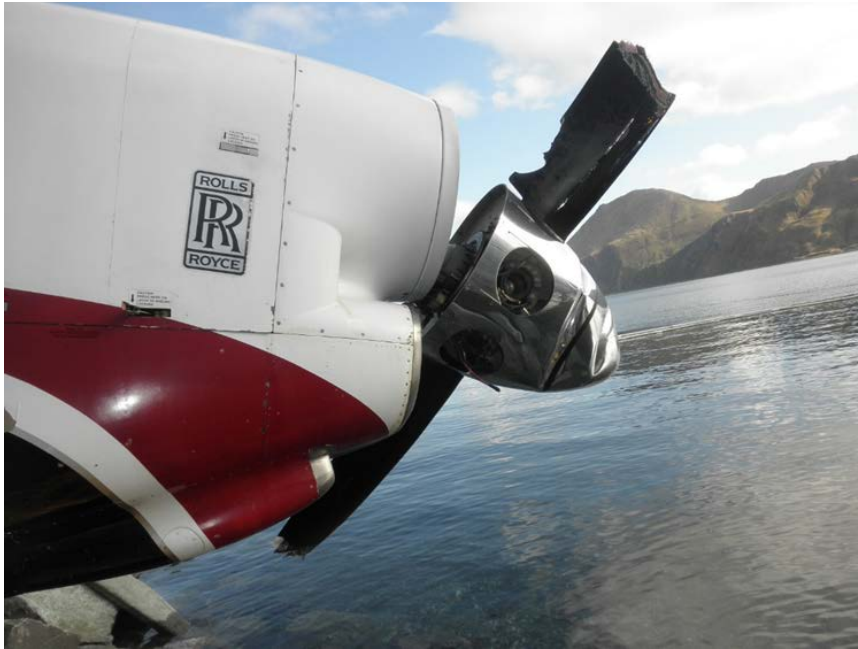
The left propeller hub was intact. Pieces of the blade, either part of the airfoil or just the blade butt, remained in all six blade locations on the hub. All of the propeller blades that still had parts of an airfoil remaining were in the feathered position. At those locations where the airfoil was missing, the blade retaining clamps were in place with the retaining bolts in place and safety wired. Blades Nos. 1, 3 and 4 were missing, although the base of each blade remained in the hub (Figure 4). Blade No. 2 was in place in the hub and the blade was fractured transversely across the airfoil

about 28.5-inches from the disk to the fractured end. Blade No. 5 was broken about 48-inches from the disk to the fractured end. Blade No. 6 was broken about 48-inches from the disk to the fractured end. The three blades that were missing from the left engine's propeller hub were all recovered. There was a propeller blade that was recovered from the water that was about 48-inches long. There was a propeller blade that was found hanging on the left side of the airplane from some cabin insulation that had wrapped around the butt of the blade that was about 58.5-inches long. There was a blade that was found in the cabin that was about 57-inches long.

*Figure 4 Damage to left propeller*

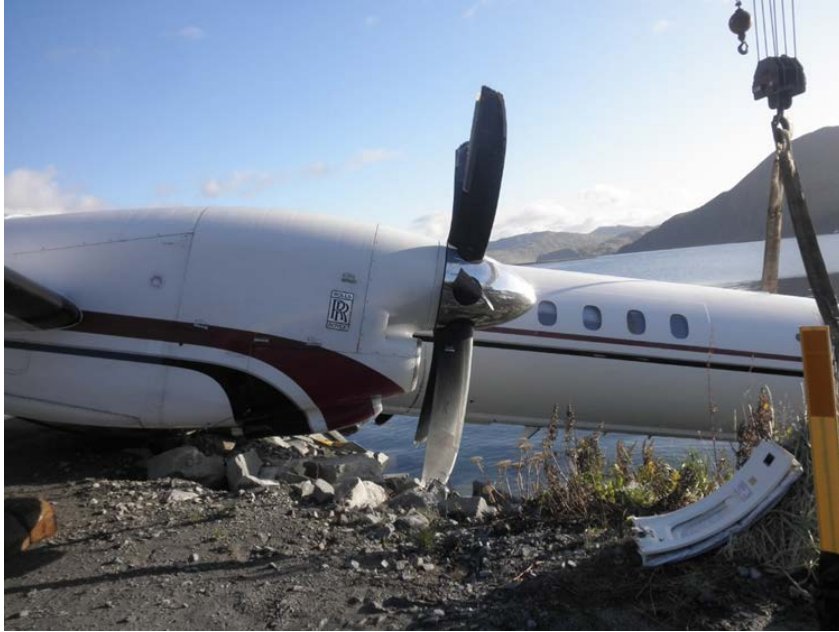
The right engine was intact and the propeller could be turned with little force. All six right propeller blade tips were broken away between 53.5-inches and 56.75-inches from the disk to the fractured end (Figure 5).

*Figure 5 Right engine and propeller*
